**NATURAL ICING FLIGHT TESTS AND ADDITIONAL SIMULATED  
ICING TESTS OF A UH-1H HELICOPTER INCORPORATING AN  
ELECTROTHERMAL ICE PROTECTION SYSTEM**

R. H. Cotton  
Lockheed-California Company  
P.O. Box 551  
Burbank, Calif. 91520

July 1978

Final Report for Period 17 February 1977 - 15 April 1977

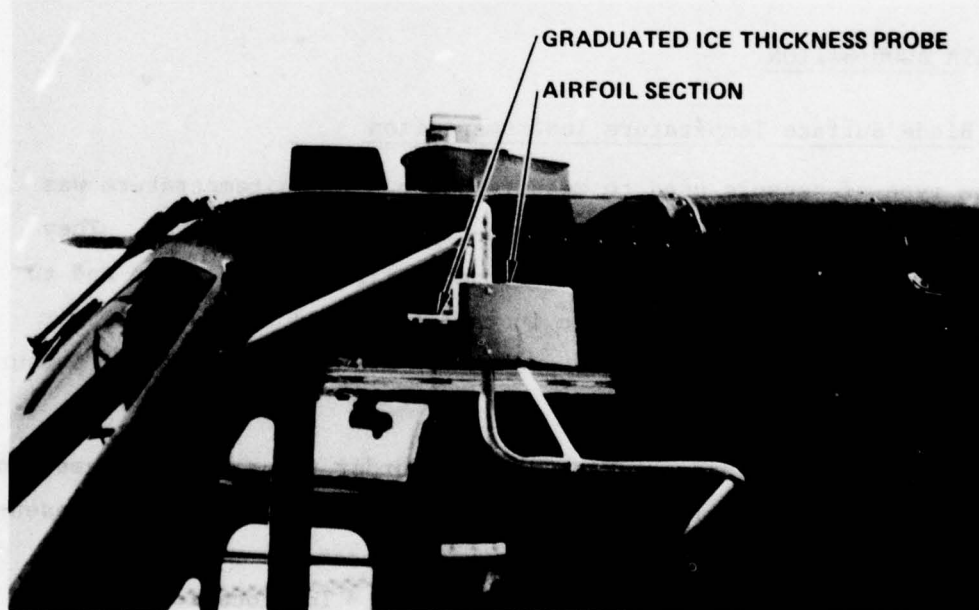
Figure 3. Visual Ice Accretion Indicator Mounted on Copilot's Door Following a Spray Rig Test

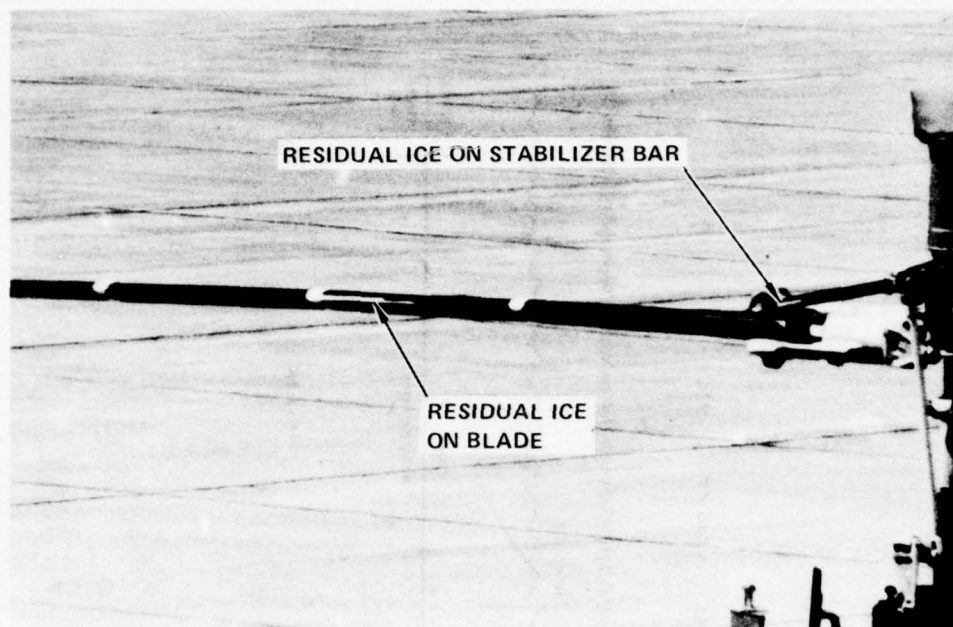
Figure 11. Residual Ice on the Stepped Leading Edge Surface of Zone 5 and on the Stabilizer Bar on Return from a Natural Icing Flight through a Broken Cloud Condition at  $-18^{\circ}\text{C}$

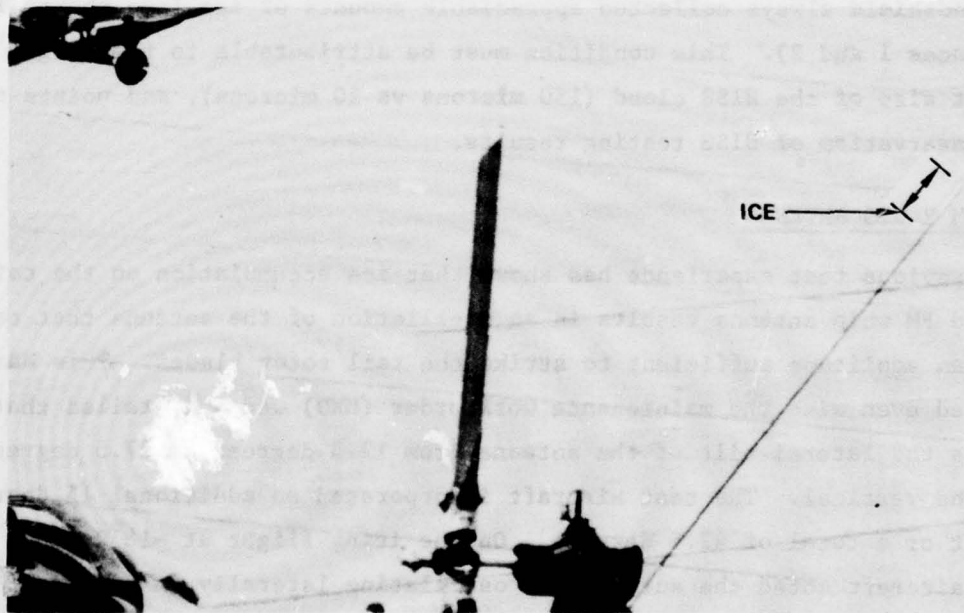
Figure 15. Ice on the FM Radio Antenna After  $-18^{\circ}\text{C}$  Natural Icing Flight

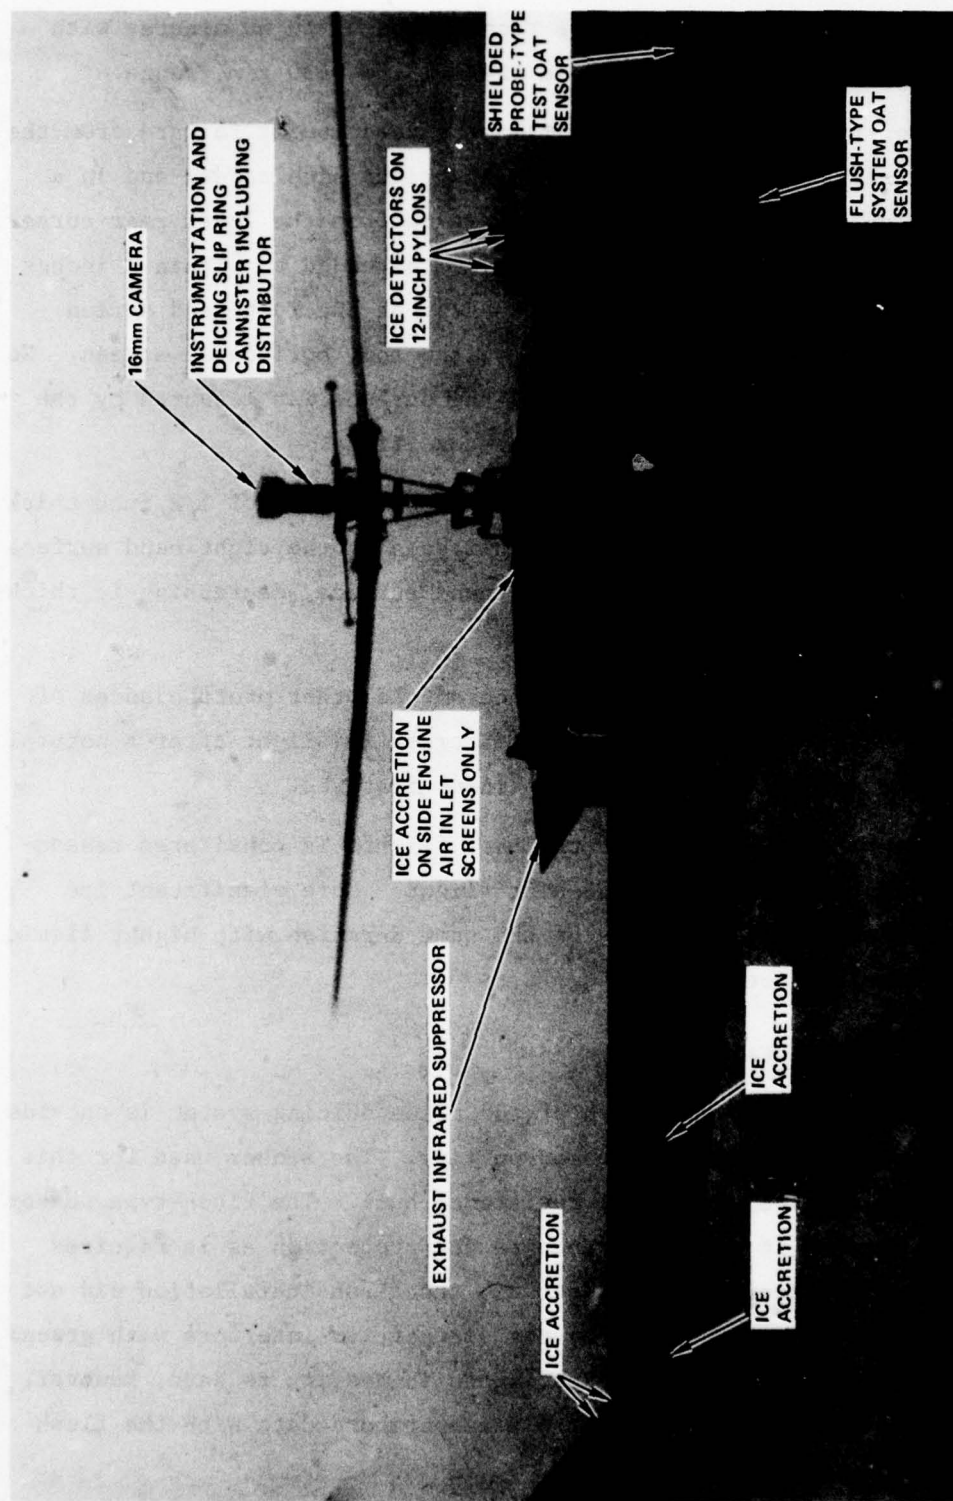
Figure 16. Test UH-1H Aircraft Following 21 Minutes in Natural Icing (FLT 162,  $-8^{\circ}\text{C}$ ,  $0.3 \text{ g/m}^3$ )

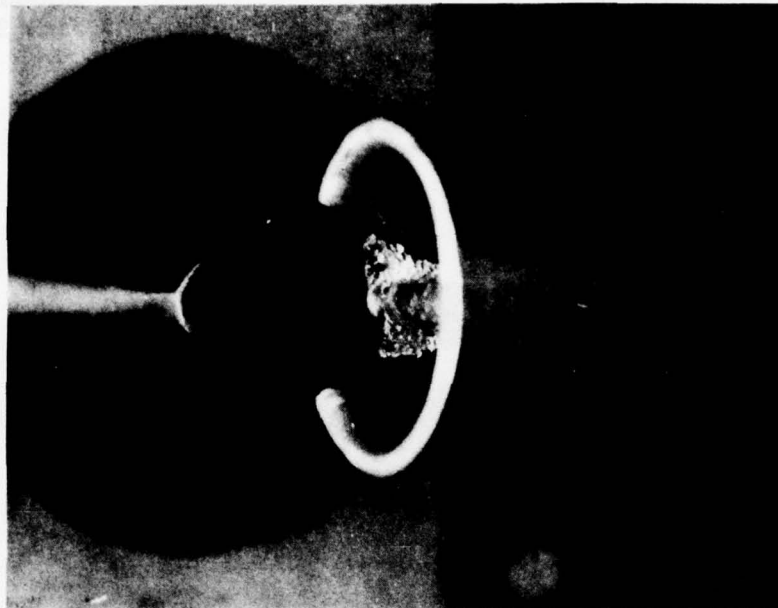
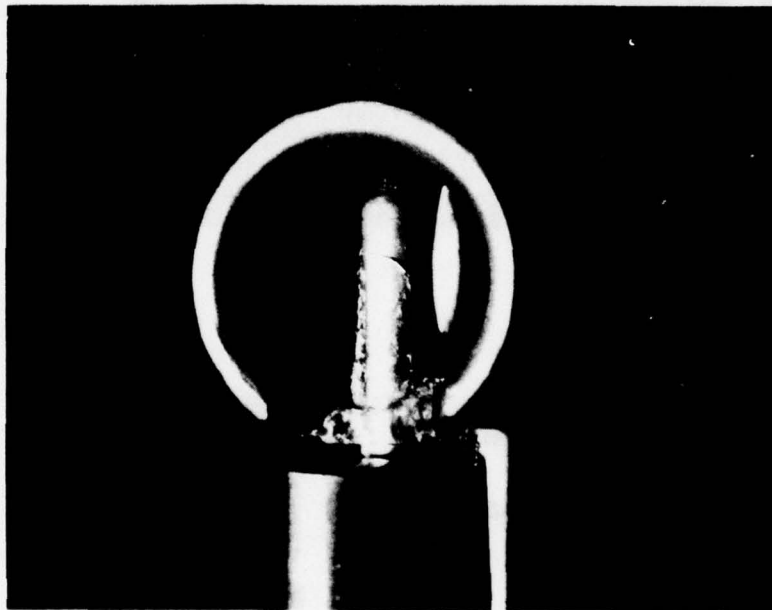
LTR-LT-76  
Fig. 27a

FIG. 27(a)      SHOWING ICE THAT FAILED TO SHED  
FROM PROBE

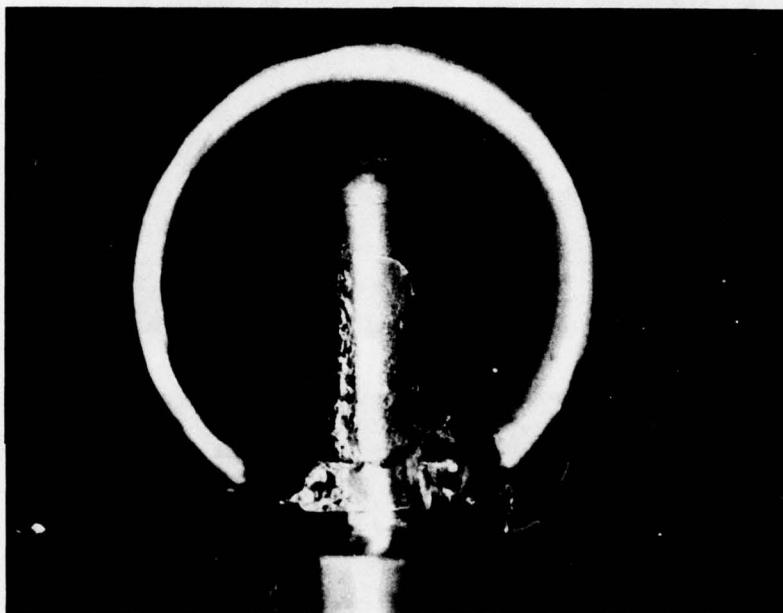
LTR-LT-76  
Fig. 27b

FIG. 27(b)      SHOWING ICE THAT FAILED TO SHED  
                         FROM PROBE
